6690A-02

S E R V I C E N O T E

6690A DC POWER SUPPLY

Serial Numbers: US0000000/US41230162 & MY41000101/MY41000282

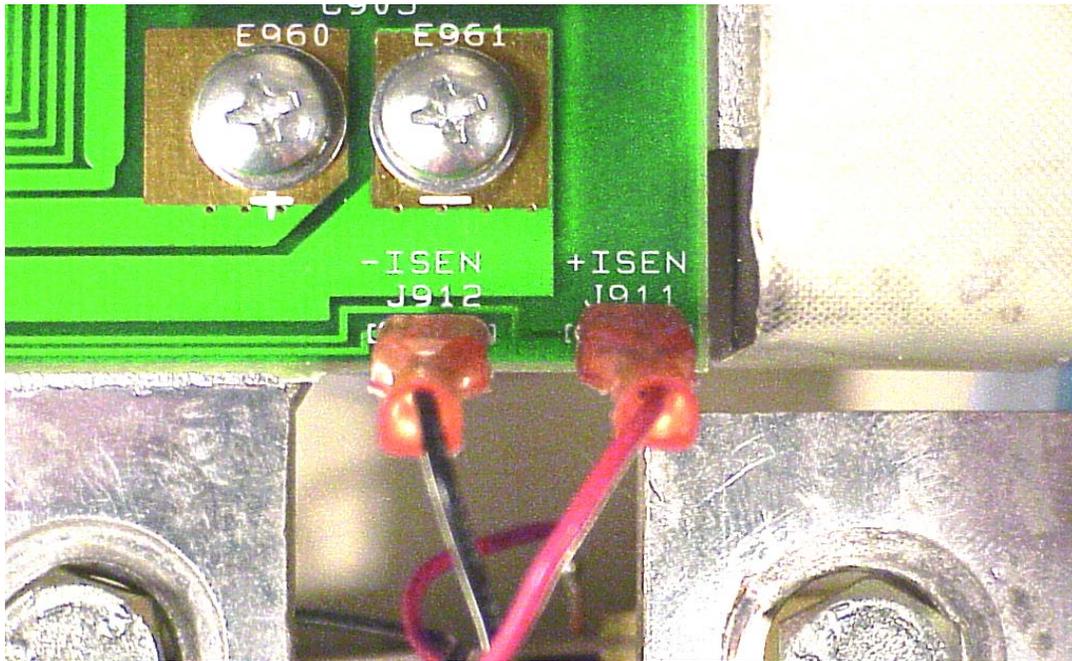
The Current Shunt (Circuit Reference “R900”) may have intermittent sense wires, which may cause Instability of Current Regulation, Current read back and current programming may become unstable.

When the push-on connectors become intermittent the output current will become unstable. Loose push-on connectors can cause the output current to change dramatically. The current can change from any set current, and may go to the maximum rated output current of the instrument.

The first picture below shows how the Shunt “R900” is connected using the term-crimp connectors. The Shunt “R900” is connected to (-ISEN J912 Black wire) & (+ISEN J911 Red wire).

Cut the terminal-crimp connectors off of both wires and discard the connectors. Make this cut as close to the terminal-crimp connector as possible. Carefully strip the wires to approximately 8mm and solder the wires, and avoid burning the wire insulation and the printed circuit board.

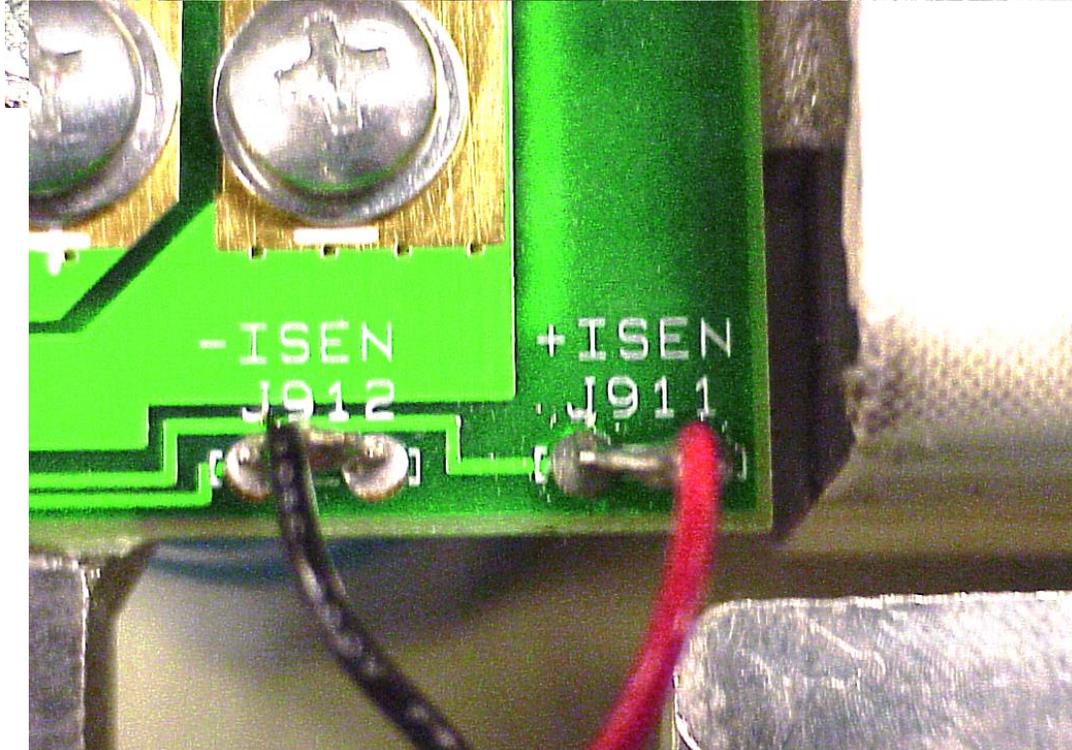
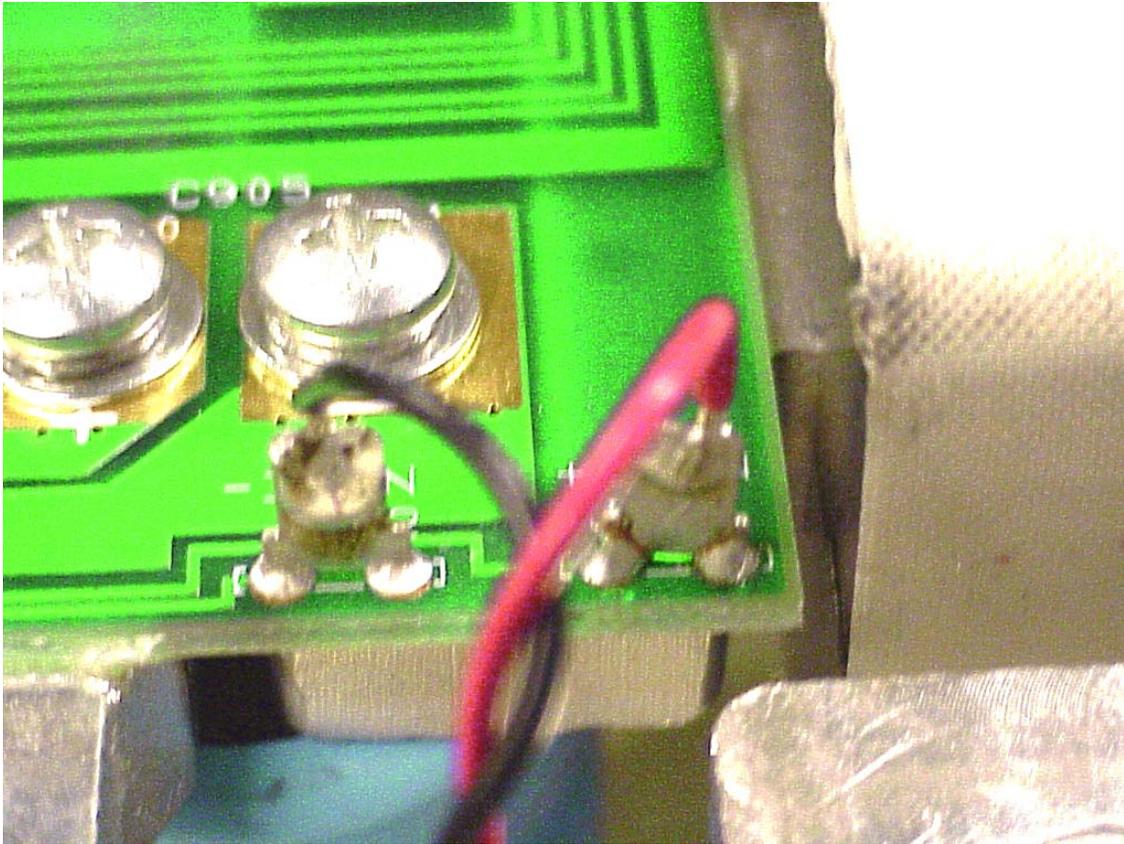
The second and the third pictures show how the Shunt “R900” is connected when soldered.

This strip length will be used to solder to the connectors to (-ISEN J912 Black wire) & (+ISEN J911 Red wire). The length of these wires is critical. If the strip length of the wires is too long, the wires may cause a short to adjacent components. If the length of the wires is too short the solder connections may be poor. If replacement of the Red or the Black wire is required the same type and color wire should be used (22 AWG. 300V 105C).

The wires should be connected as shown below. The holes in the male connectors should be used to solder the Red and Black wires to the printed circuit assembly marked (-ISEN J912) & (+ISEN J911). Do not mix the Red & Black wires when making this modification. See picture below for details. The pictures shown below show the required modification.

1. Inspect the solder connections to determine the solder joints are acceptable.
2. Inspect the printed circuit board to insure the solder joints are acceptable around (-ISEN J912) & (+ISEN J911) connectors.
3. The wires that are now soldered to (-ISEN J912 Black wire) & (+ISEN J911 Red wire) MUST be twisted.
