The Independent Fact Group

Recovery damage to the visor

STATEMENT REPORT

Subject: Recovery damage to the visor
Type: Statement
By: Johan Ridderstolpe and Björn Stenberg
Status: Proved
Date: 1 May 2000
Version: Report - English

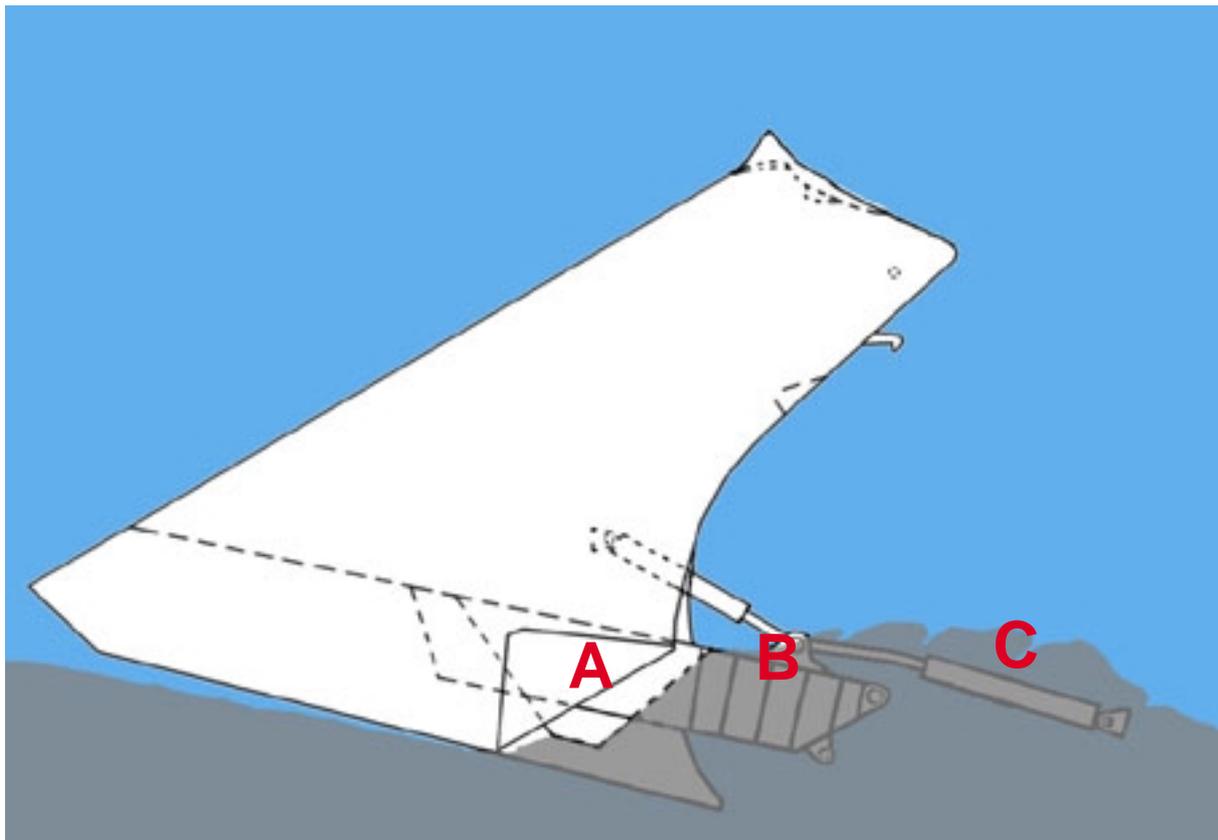
Picture 1. The picture shows the visor seen from the starboard side, standing upside down resting on the visor housing (A) with the visor arms (B) and the starboard hydraulic actuator (C) covered with mud. On the video (visiri) it can be seen that the rest of the visor was standing free from the bottom and that there were no contact marks on the bottom around the front of the visor.

The upper part of the visor, now closest to the seabed, can be seen free from the seabed all way around the visor.

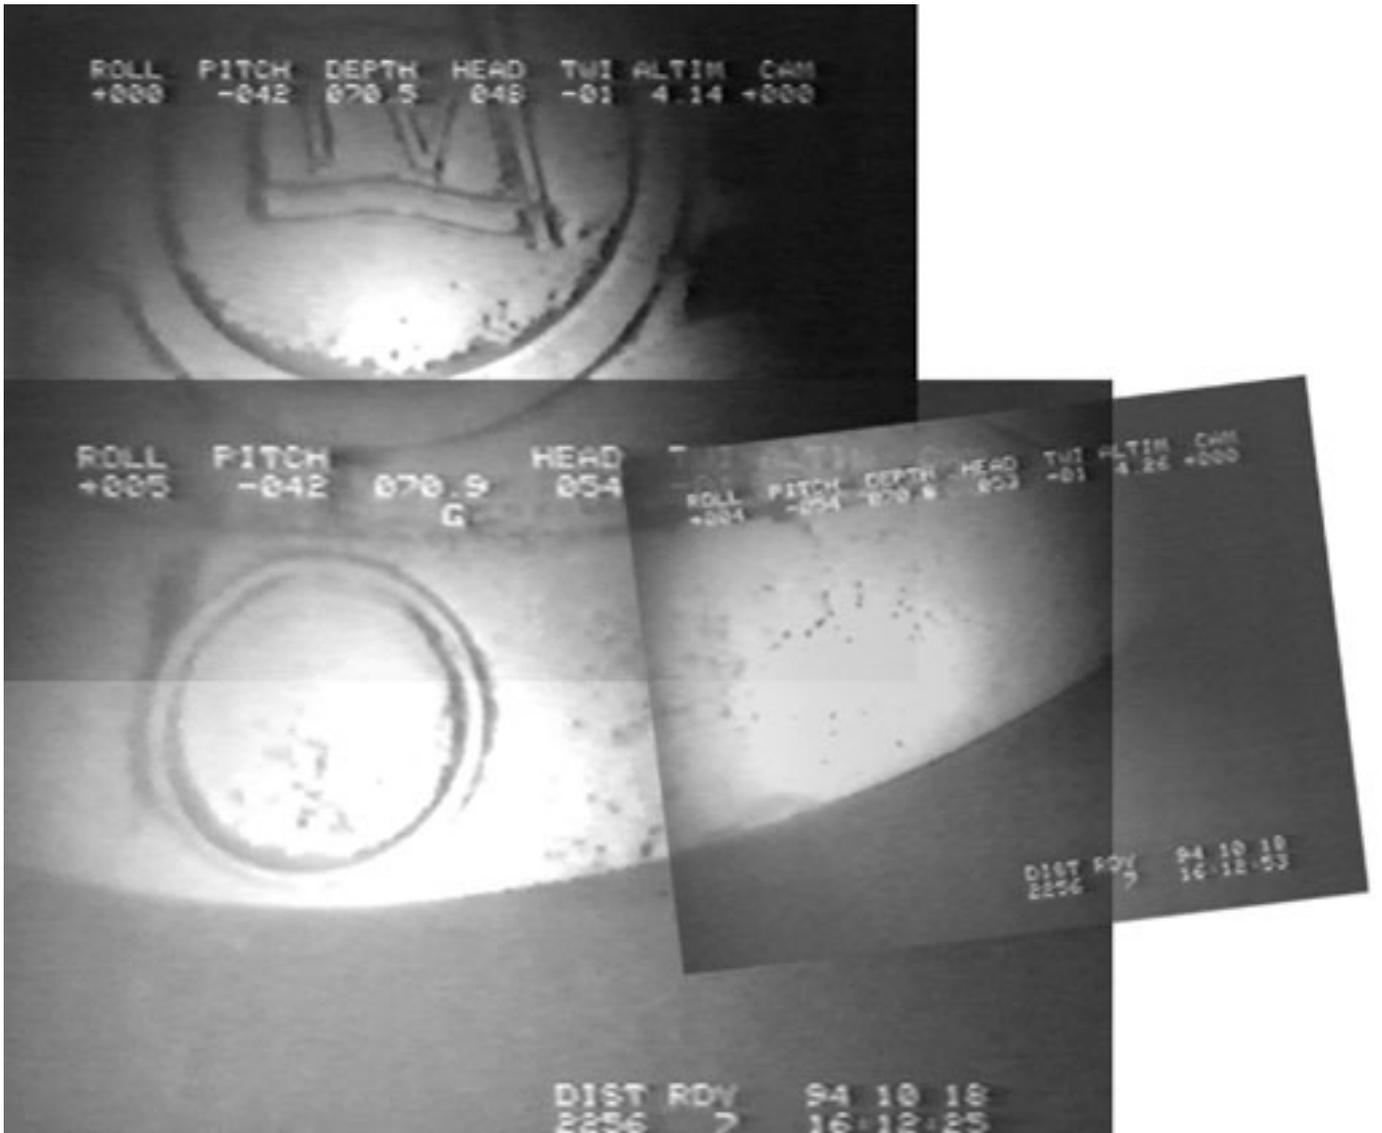
Picture 2, Mosaic. The picture show the front of the visor and a part of the starboard upper side. The visor is standing upside down on the seabed. From the video "visiri" 94.10.18 at 16.12.25.

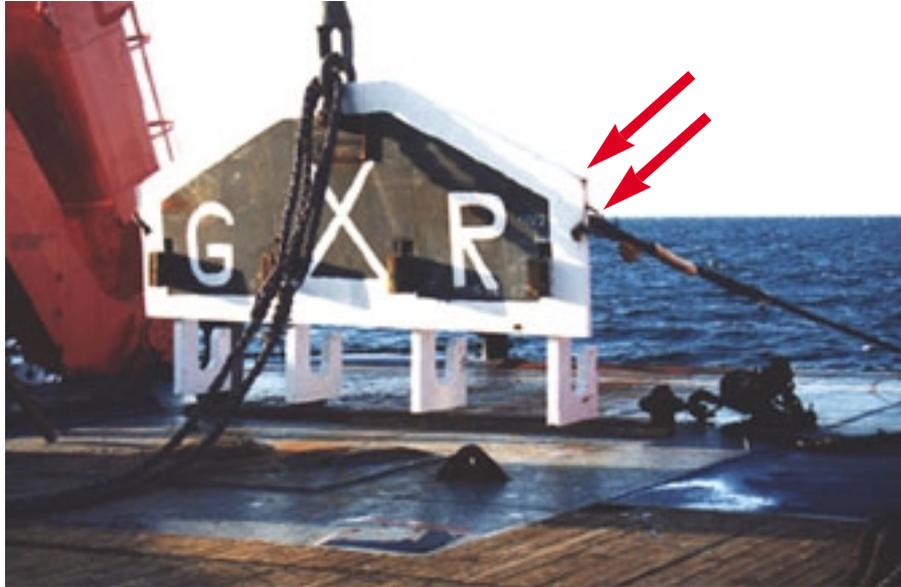
The fastening points have been cut off and moved down slightly. The second design are shown here in picture 7.

Picture 7. The picture show the second redesign before the second attempt to recover the visor. The fastening points for the side wires have been cut off and rewelded further down, see the arrows.

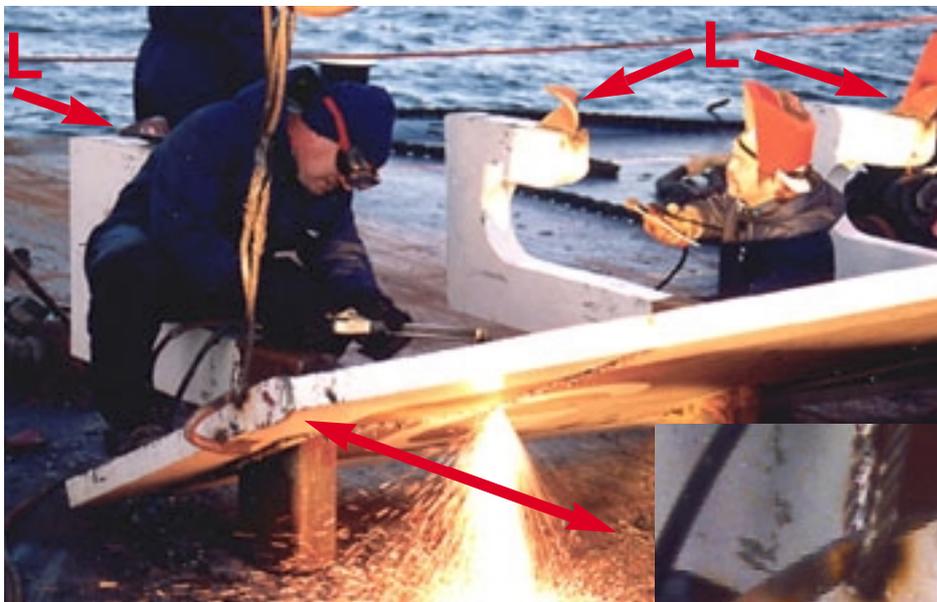
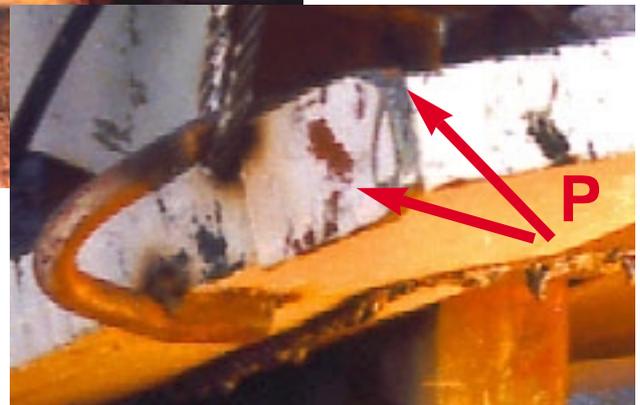
The third redesign is shown in picture 8a. This involved welding triangular lugs to the four hooks on the yoke (L).

This picture shows that there was a third attempt to recover the visor. It resulted in severe damage to the triangular lugs which were all bent sideways (L).

Picture 8a and 8b. There is some red paint (P) that indicates contact points between the yoke and the visor.

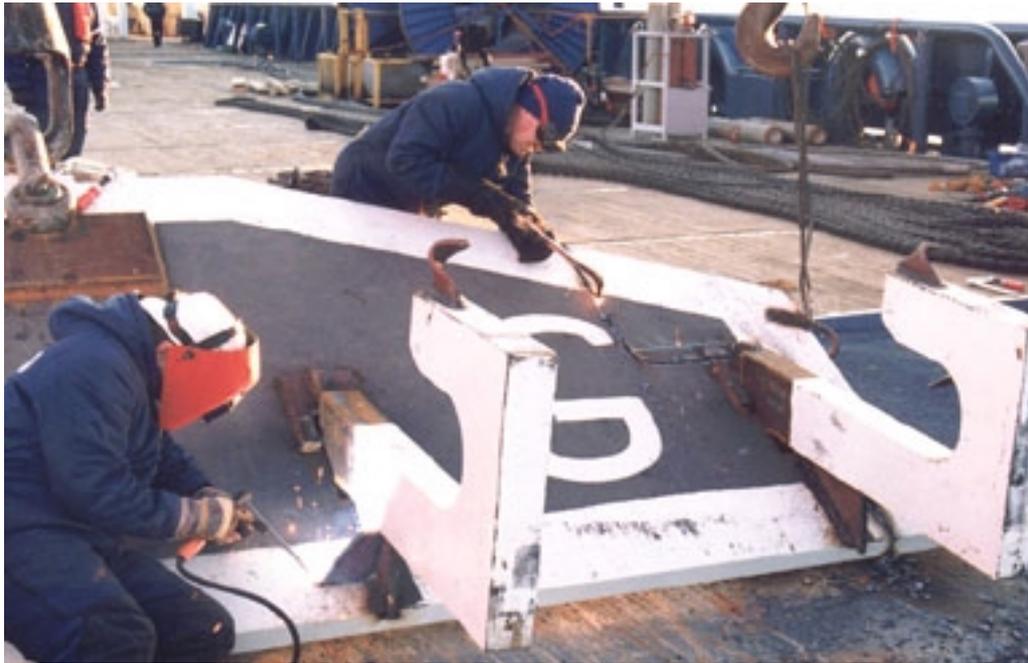
Picture 9. The picture shows the fourth redesign. It involved removing major parts of the upper corners of the yoke by means of cutting, and also cutting away material on each side of the yoke to make it narrower.

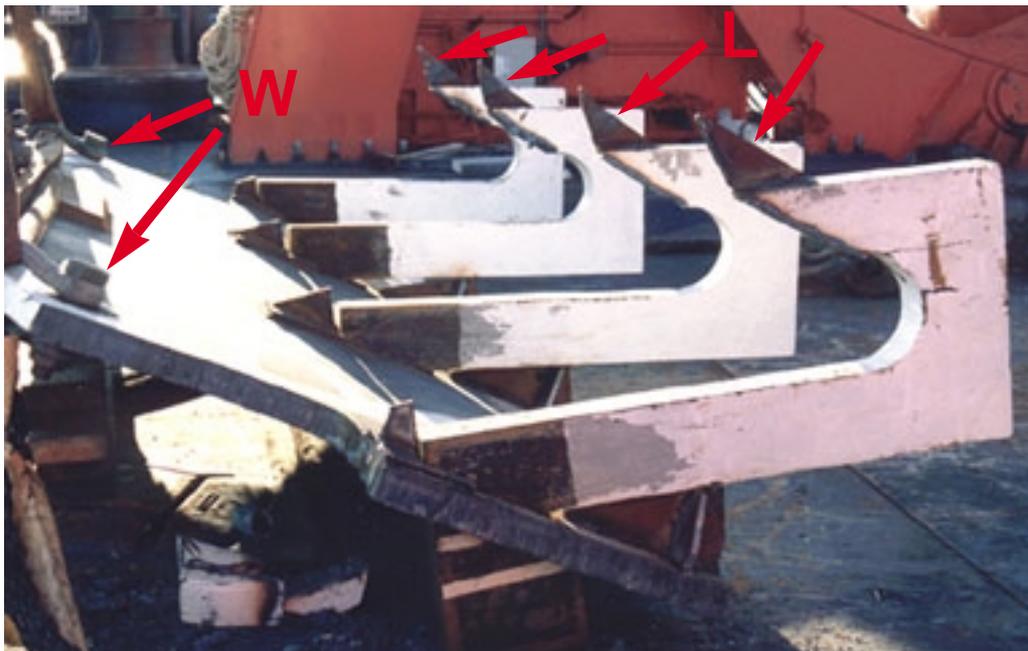
Picture 10. The picture shows the result of the fourth redesign. Material from the hooks was also cut away, and the relative angle between the yoke and the hooks was changed. New holes were cut for the two wires or thick ropes (W) that were attached on each side of the yoke. The triangular lugs on the hooks have been repaired (L).

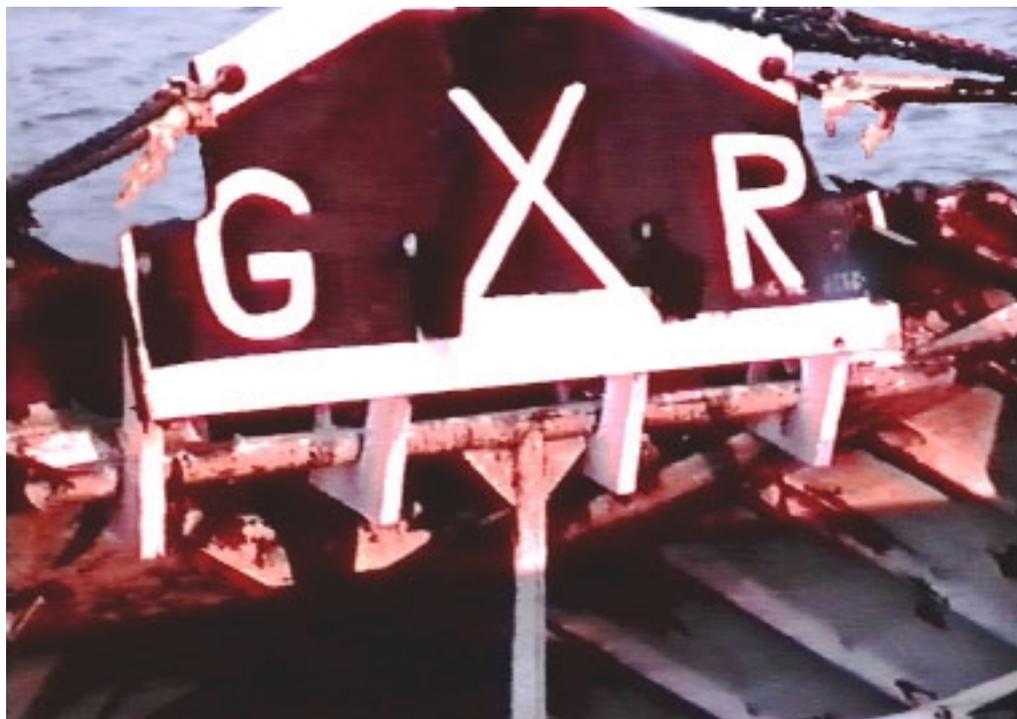
Picture 12. The hooks on the redesigned yoke attached to the transverse visor beam slid slightly towards the starboard side of the visor.

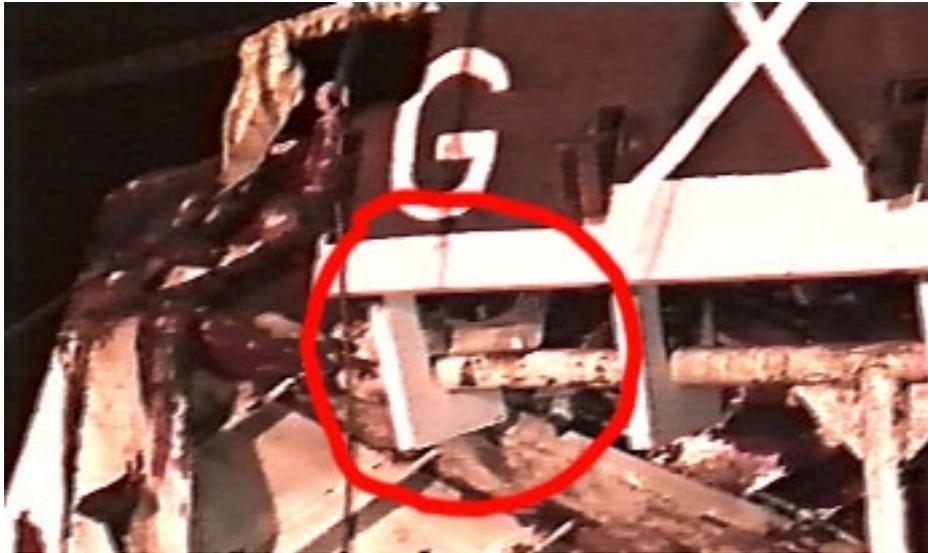
A close up on the hook position on the starboard side of the visor shows that the outer hook had become attached around the beam and through the large round hole in the construction. It will be shown that the hooks damaged the visor construction in the course of all the attempts to get the yoke attached to the visor.

Picture 13. Detail of the hook attached to the visor starboard side.

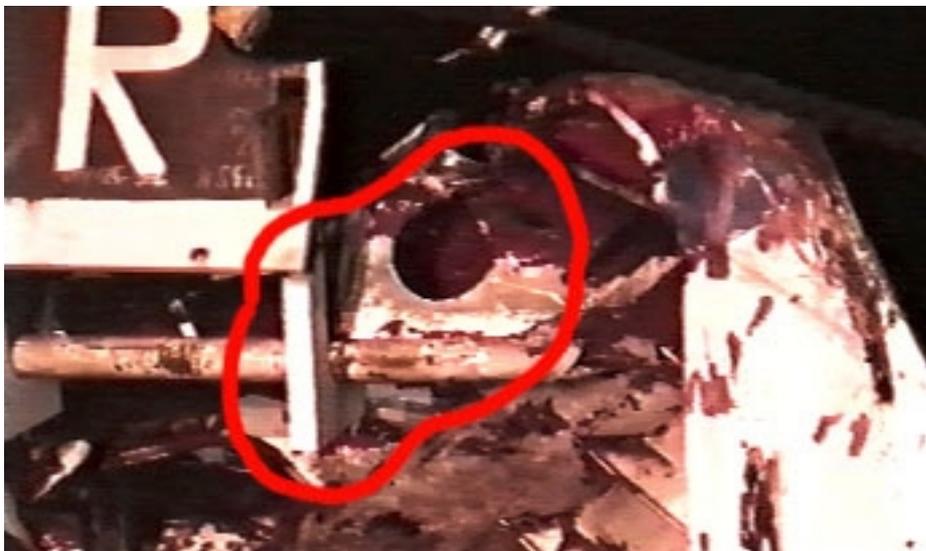
On the port side, the outer hook had become attached just beside the round hole in the construction. However, both the round holes, on the starboard and port side (in the construction) were demolished during the recovery operation. As the construction here was a part of the bottom plating of the visor (the most destroyed part of the visor), any damage here would have had an effect on this same bottom plating.

Picture 14. Detail of the hook attached to the visor port side.

As the yoke was redesigned and made narrower, it could "move" in a transverse direction during the various attempts to get the yoke attached and therefore the construction on both sides was demolished during the recovery operation.

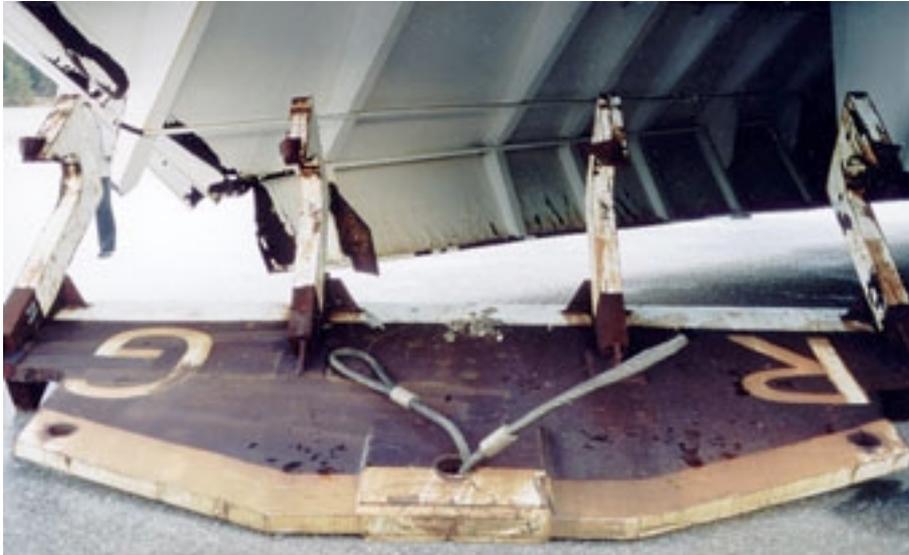
The yoke was also damaged due to the final attempt to recover the visor. This can be seen from the damage to the hooks, more specifically the triangular lugs, where the three "starboard" lugs have again been bent to "starboard".

Picture 15. Three hooks are damaged. The outer port side hook, to the right of the picture, was not damaged.

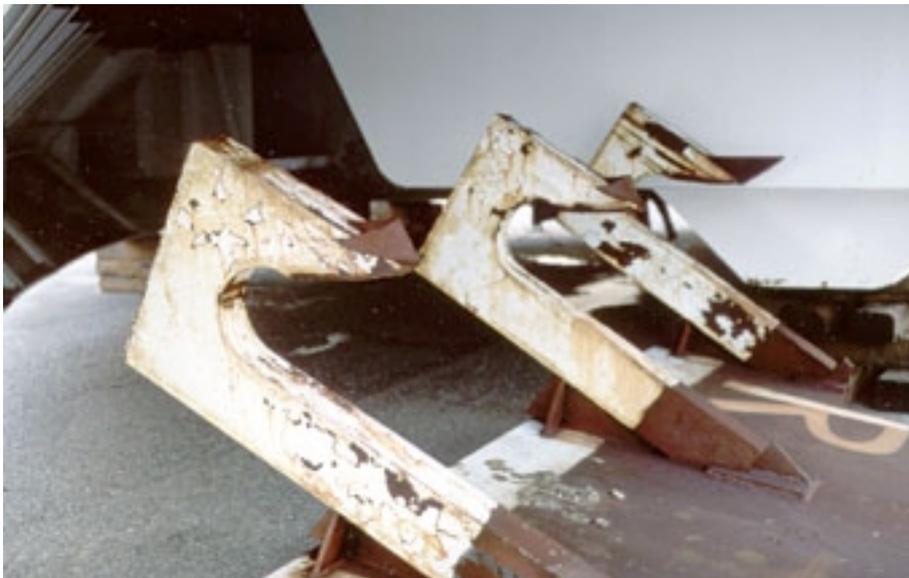
Picture 16. The two middle hooks seen here have been severe damaged.

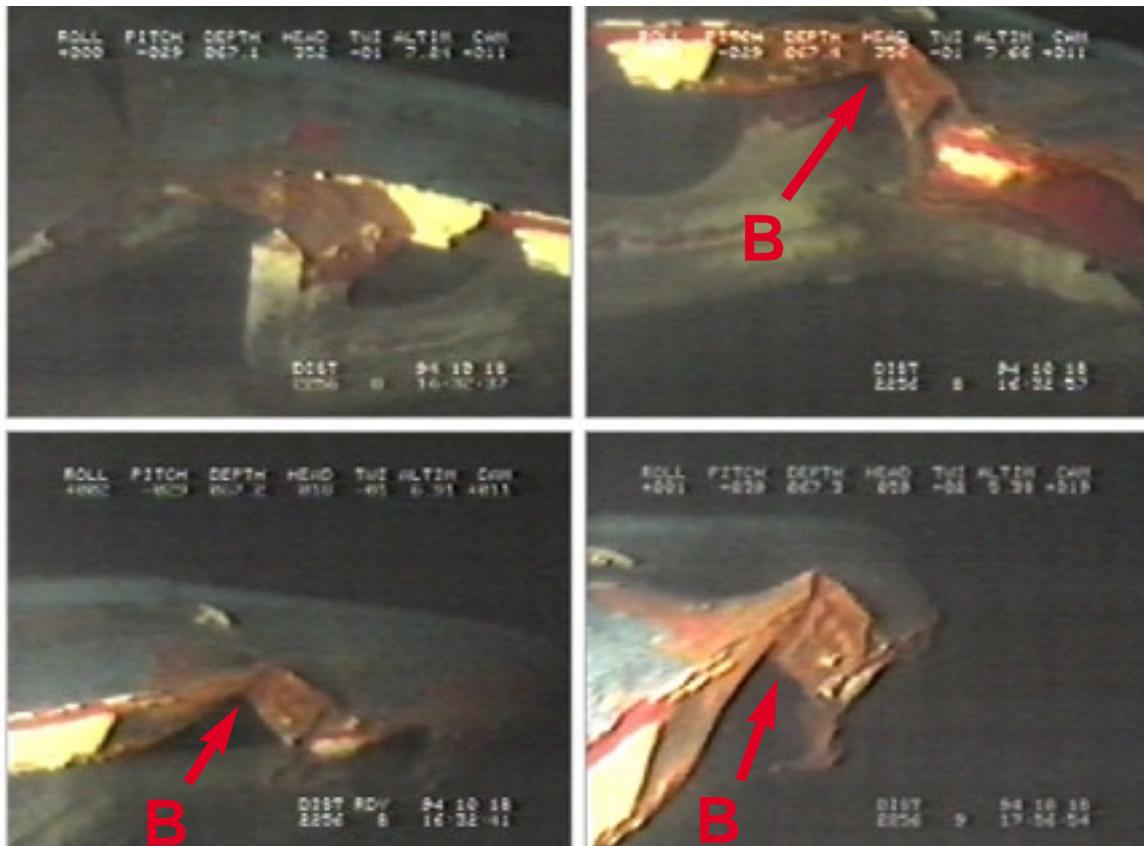
Picture 17 from "visiri 94.10.18 at around 16.32. The beam (B) on the port side of the visor bottom was not completely broken before the recovery, but damaged. Compare with pictures 22 and 23.

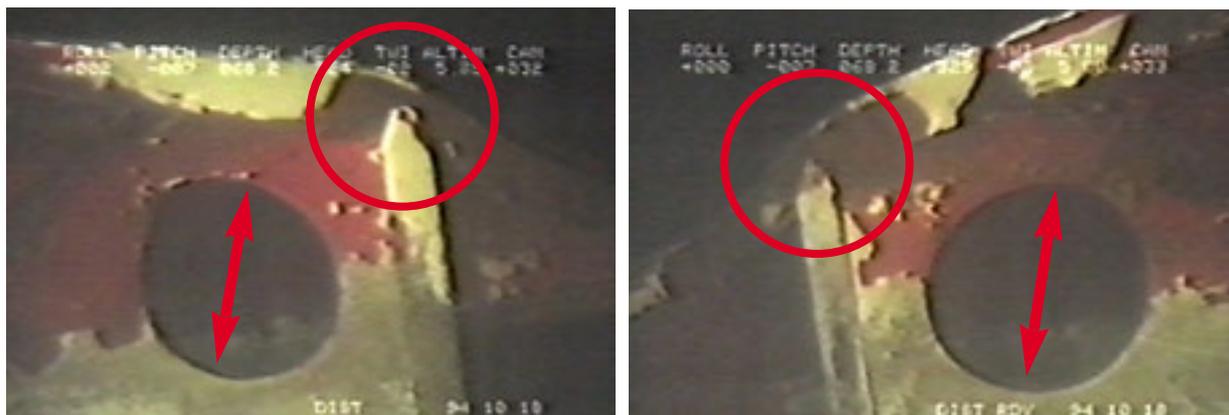
Pictures 18 and 19 from "visiri 94.10.18 at around 17.57. The two round holes (arrows) on both the starboard and port side were not damaged before the recovery. Compare with the damage after the recovery, pictures 21 and 22. Also compare the connection between the vertical and transverse beam within the red circles with the same area in pictures 21 and 22. This clearly shows that the bottom of the visor was bent further forward as a result of the recovery operation, resulting in separation between the horizontal and vertical beam.

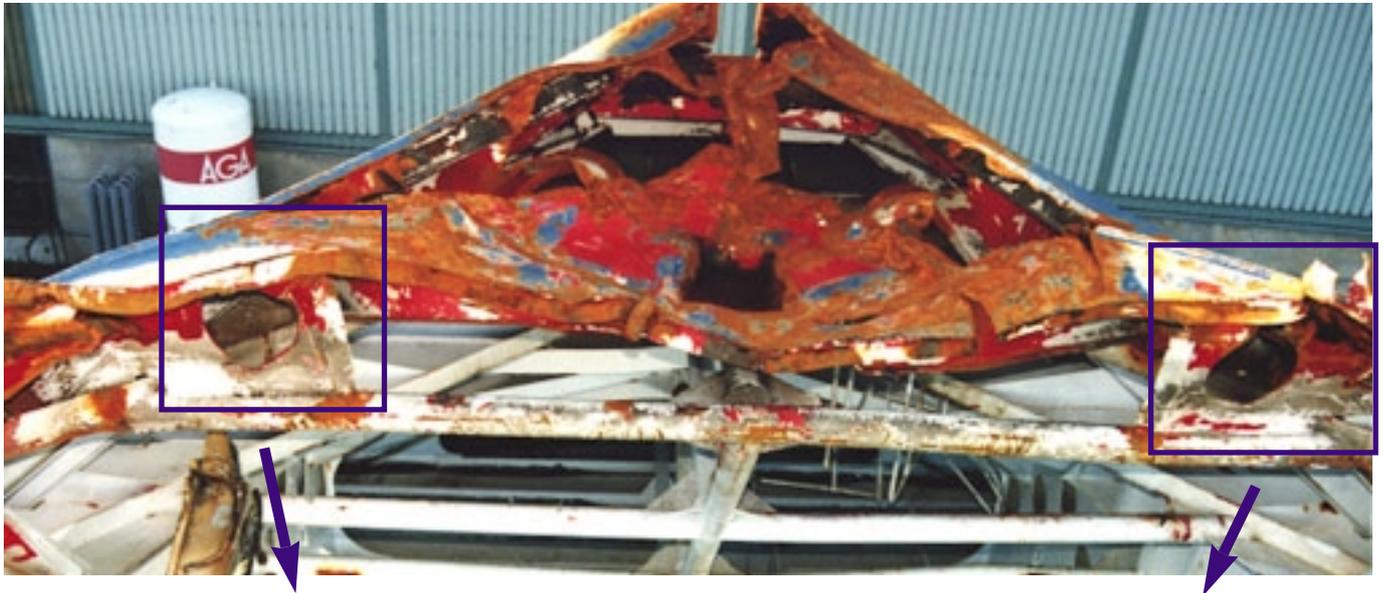
After the visor was recovered, it was found to be extremely damaged. The bottom plate itself was "pushed up" and the aft part of the same plate was bent up. Other damage seemed to have been "pushed down" indicating damage in both a downward and upward direction. The Commission did not, however, identify the damages caused by the recovery operation. Five items of the damage are identified below.

Picture 20. Overview of the bottom plate damage and details below.

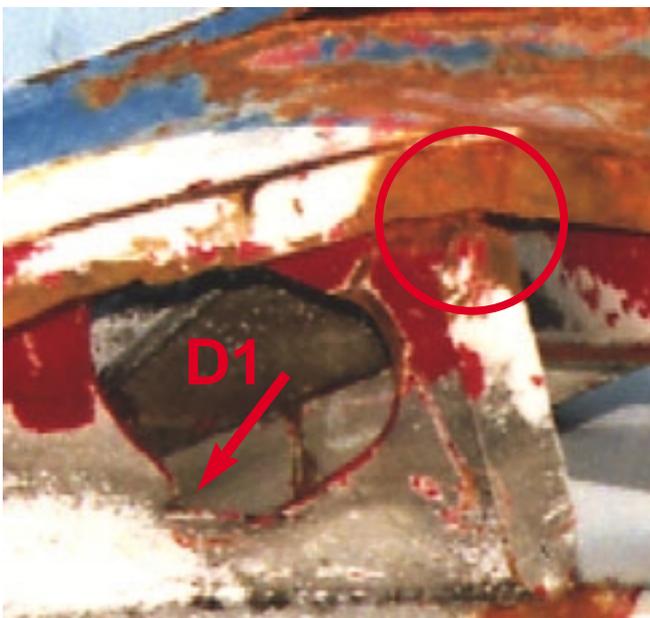
Picture 21. The round hole is damaged (D1) in an aft direction. The outer starboard hook on the yoke has broken the plate with the hole when twisting around the transverse beam.

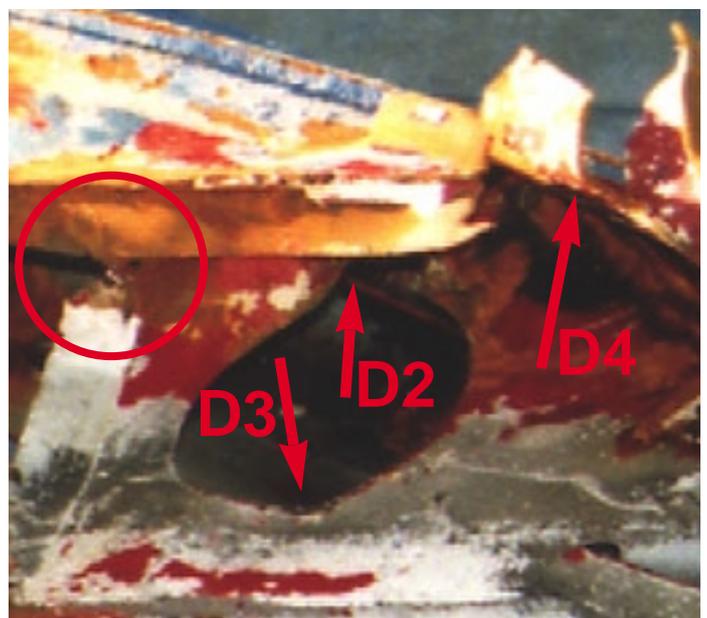
Picture 22. The round hole is damaged (D2) in an forward direction. The outer port hook on the yoke has broken the plate with the hole when twisting around the transverse tube beam. It has also created buckling (D3). The yoke also broke the beam (D4) as can also be seen in picture 23.

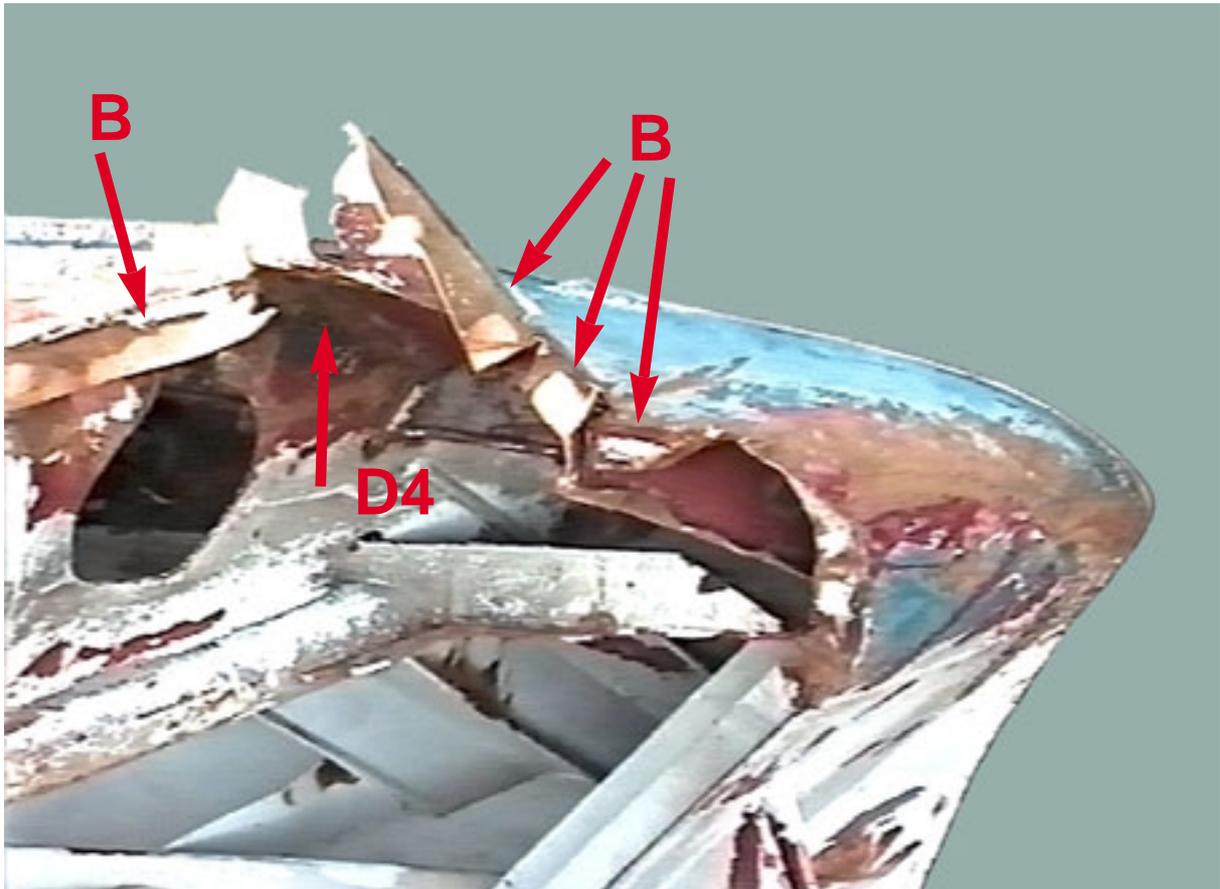
In the picture below, it can be seen that the transverse beam (B) has been ripped apart in an upward direction (D4) in the picture.

Picture 23. The port bottom side of the visor after the recovery.

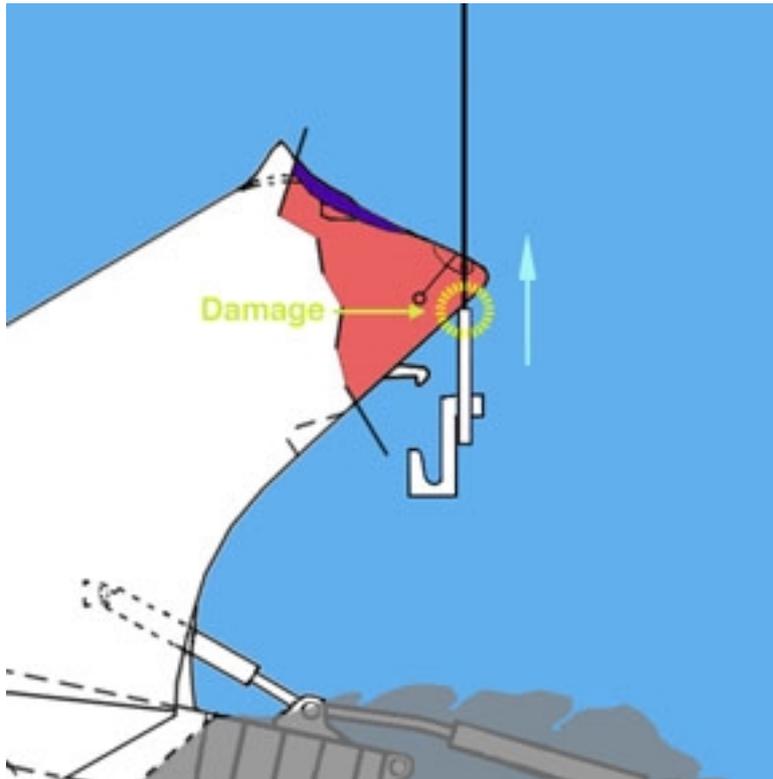
Damage type one. Damage from the yoke due to failure to attach it to the visor (dimensioning problems). The yoke may have hit the visor in several places.

Picture 24. Possible damage caused during the first attempt to recover the visor.

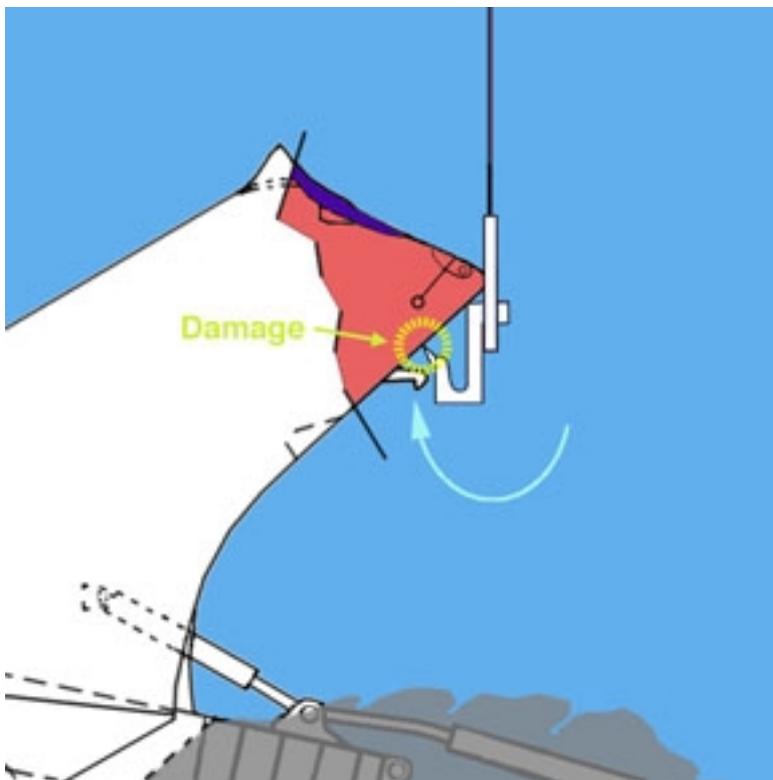
Damage type two. Damage from the yoke as the modified hooks with sharp lugs hit the visor. The lugs were bent as a result of hitting the visor. Score marks must have been caused. The hooks may also have ripped and damaged other parts of the visor.

Picture 25. Possible damage caused during the second, third and fourth attempts to recover the visor.

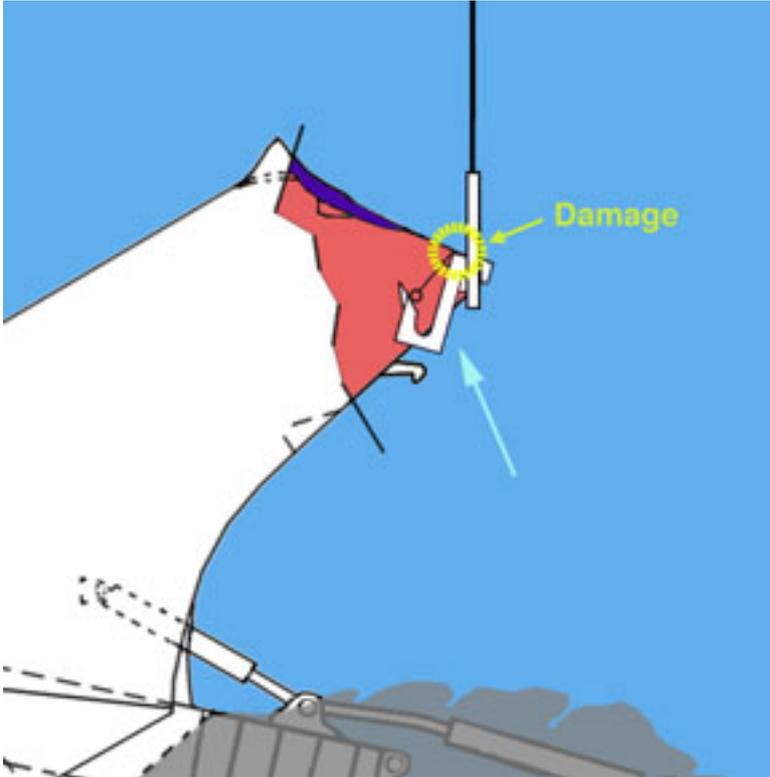
Damage type three. Damage from the yoke as it was forced to attach to the visor beam.

Picture 26. Possible damage caused during the third and fourth attempts to recover the visor.

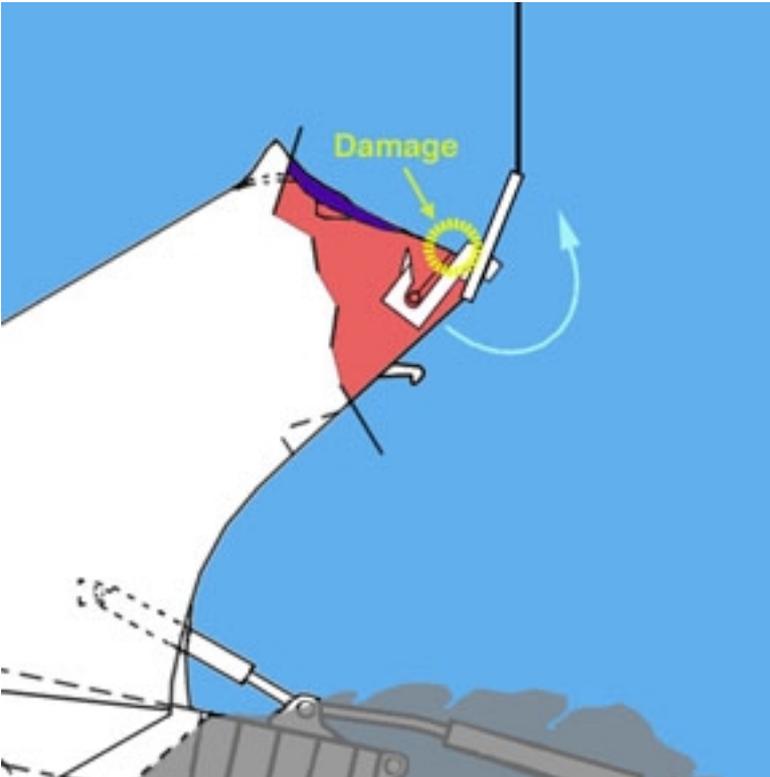
Damage type four. Damage from the yoke after it was forced to attach to the visor. When the visor was lifted it was damaged due to bending force. This caused further separation between the transverse beams and the plating and may also have damaged the visor bottom plating further.

Picture 27. Possible damage caused during the final attempt to recover the visor.
