Condition-based Maintenance in Open Cast Mining

Non-contact and Cost-effective Monitoring and Differentiation Between Good/bad Support Rollers on Conveyor Belts in Open Brown Coal Cast Mining

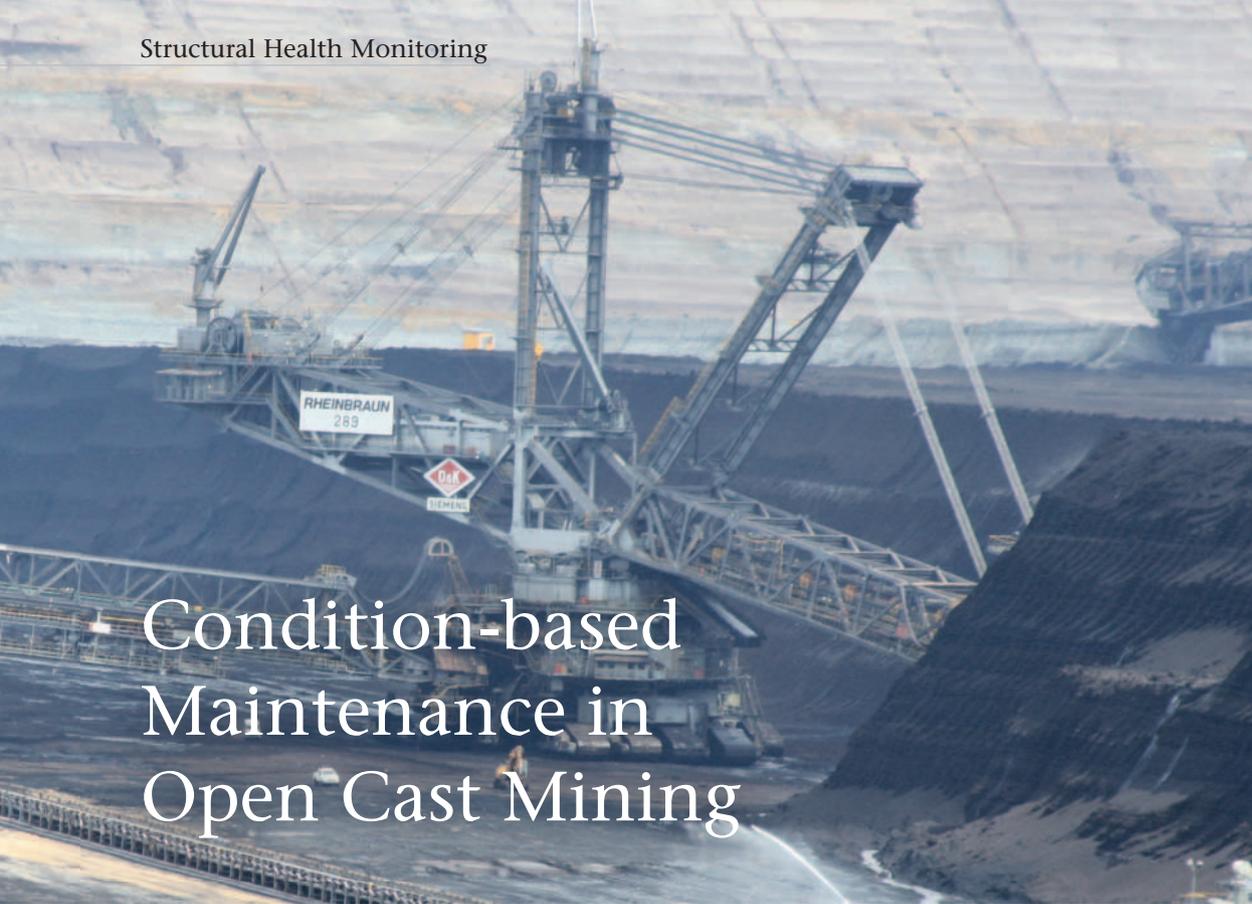
Fig. 1: Conveyor belts for excavated material.

The conveyor belts (fig. 1) have up to 12 MW driving power, are 2.8 m wide, typically 1.5 to 3 kilometers long, and

move at speeds of e.g. 7.5 m/s. The belt is carried by support roller arrays that consist of 3 support rollers each. Monitoring this technology regularly is already challenging because of the dimensions and distances involved.

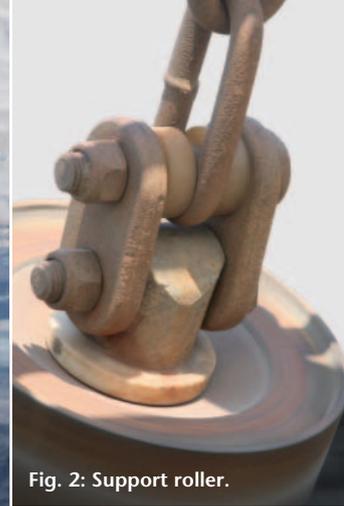
Fig. 2: Support roller.

on support rollers during operation (fig. 2) and to investigate their vibrational behavior over a broad frequency range. The spectral signatures of good and defective bearings have already been ascertained in tests. Now all that is needed is reliable and fast measurement technology to acquire the spectra. The option of gluing on accelerometers, or attaching them with magnets would take too much time for every roller and the dirt on the rollers would mean that the measurement point would have to be cleaned every time. In addition to that, user safety needs to be taken into consideration. The support rollers are tight up against the conveyor belt moving at great speed and are thus in an area with a high risk of injury.

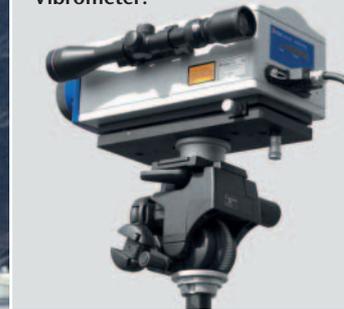
Fig. 3: RSV-150 Remote Sensing Vibrometer.

A viable alternative is a non-contact process that can be used from a safe distance. The RSV-150 Remote Sensing Vibrometer (fig. 3) is perfectly suited for this task. This optical solution saves the installation time while simultaneously ensuring safety, as it is possible to make a measurement over several meters. In the application shown here, the stand-off distance was 5 to 7 m. The RSV-150 is a universal instrument for non-contact acquisition of surface and structural vibrations over large distances. Depending on the amplitude and the backscattering properties of the surface, the distance from the object can be between 5 m and 150 m. fig. 4 shows the target alignment in the video image.

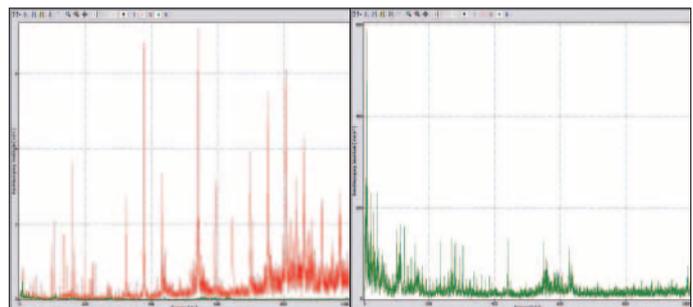
Fig. 5: Comparison of spectra of a defective bearing (red) and a good bearing (green).

- A support roller array containing at least one defective roller can clearly be distinguished from those consisting of only good rollers (fig. 5). The spectra are very different. Additional resonance peaks and their harmonics, caused by defective bearings, appear in the spectrum of the defective roller. As only the spectral frequencies are decisive and

not the amplitudes, the alignment of the vibrometer is only of secondary importance. Furthermore, the study proved that during operation, even good support rollers show high-frequency resonances, probably caused by slipping sealings. These resonances were hard to hear due to the high frequencies, but caused a lot of trouble during the automatic evaluation of measurement results produced during a trial on a support roller test rig of RWE Power AG.

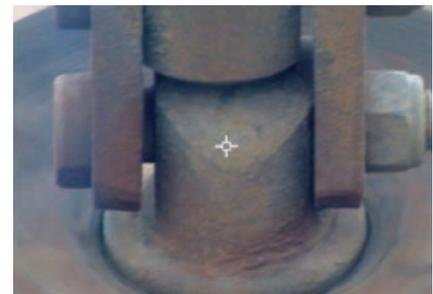
Fig. 4: Measurement point with position of the laser beam in the video image of the RSV-150.

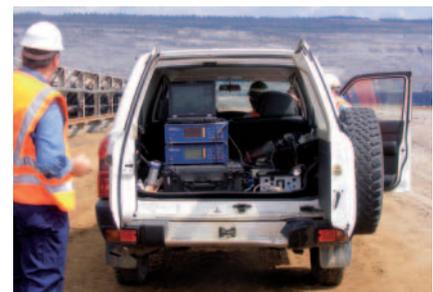
Fig. 6: Measurement technology in use on location.

The mission of the maintenance department of RWE Power AG was to perform test measurements at two conveyor belt systems with about 100 support roller arrays each. To save time, the sensor was attached to the 4 wheel drive vehicle (fig. 6) using a self-built sensor support based on a big suction cup. This means that a mobile measurement and evaluation center is available. The condition can already be evaluated on location (fig. 7). The mains power is supplied to the RSV-150 via the on-board supply system of the vehicle.

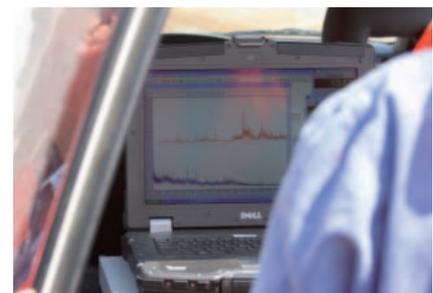
Fig. 7: Graphic representation of the results in the back of the vehicle.
