# Hard Disk Drive Development

## LDV Investigation of Unstable Air Bearing Resonance Effects on Low Flying Heads

Polytec GmbH  
 Optical Measurement  
 Systems  
 Application Note  
 VIB-D-01  
 July 2006

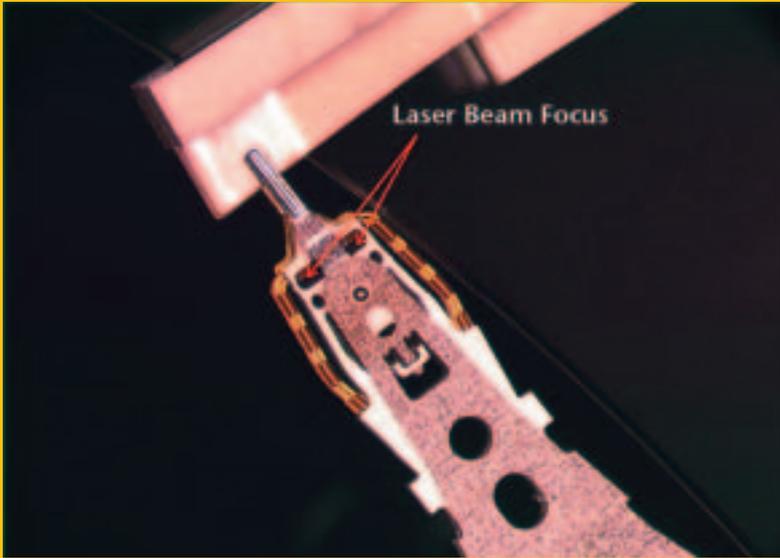
Figure 1: Read/write head showing laser vibrometer probe spots

This study was designed to measure the air bearing resonance sensitivity to various vacuum levels starting at one atmosphere. The head/disk separation is strongly vacuum dependent with 0.5 atm giving the lowest head/disk separation when compared to 1 atm. Vibration resonance modes of the air bearing were investigated at leading and trailing edges (roll and pitch sensitivity) as air pressure was reduced. A Polytec laser-Doppler vibrometer (LDV) monitored the flying behavior of the top head in the drive (Figure 1).

The front cover of the drive was modified with an optically clear glass plate so a laser probe could be projected onto the top head in the drive. The drive was then placed in a vacuum chamber with a clear Plexiglas front door. The HDD was positioned in the chamber so that a laser probe could pass through both windows and still reach the top head. This technique allows a non-invasive measurement to be performed on one head in the file. The reflected laser light carrying the vibration signal was received back at the vibrometer.

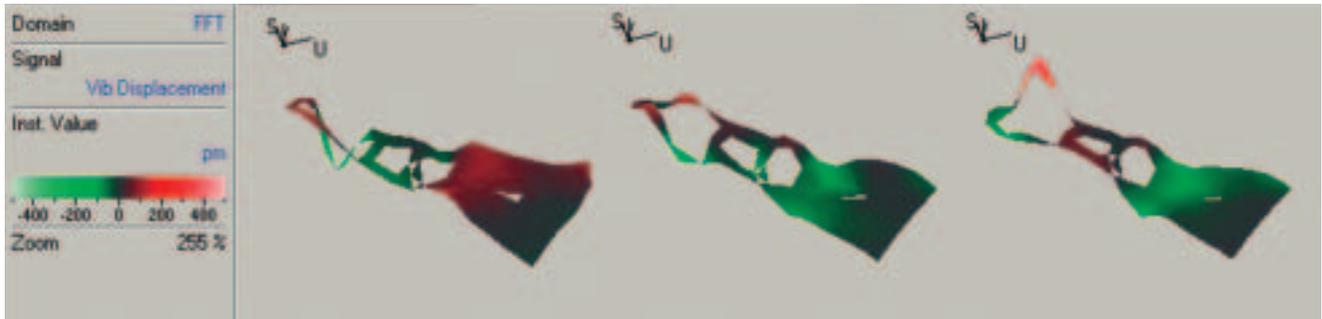
Figure 2: PSV Scanning Vibrometer measurement of bending and torsional oscillation of the suspension

For the 2-D scanning measurements, typical points of measurement on and around the slider and suspension were chosen. Figure 2 shows the 263 kHz signal that causes the suspension at the area of the head mount to oscillate with both bending and torsional modes. The rest of the suspension remained essentially stationary without any significant oscillation.

The oscillation in the vicinity of the head mount is due to the top head in the file which touches the disk during pump-down at approximately 0.549 atm and causes the 263 kHz pitch mode of the head. However, due to the instability of the head system the 263 kHz mode is also seen without the head actually touching the disk. The 263 kHz pitch mode of the head then transfers into the suspension system and the ILS.

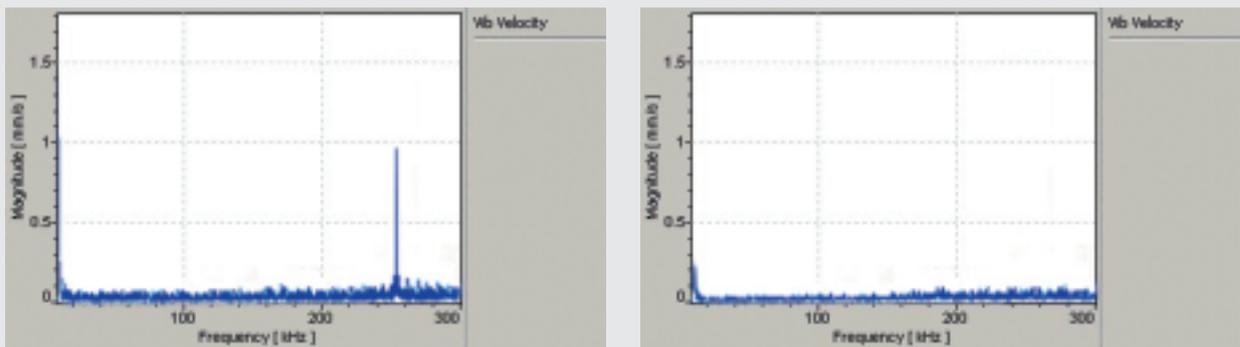
Figure 3: The 263 kHz resonance signal before (left) and after (right) application of viscous fluid

For single point measurements, the LDV was focused on the head's trailing edge corner. A 263 kHz signal from the pitch mode resonance of the head is shown in Figure 3 (left). This vibration mode was obtained at higher vacuum levels. The flying height has decreased to a point where the head is influenced by the surface roughness of the disk and the lubricant levels coating the surface of the disk.

The suspension was dampened via the load dimple that is located either at the 50% or at the 33% separation point of the head on the suspension. A suitable viscous fluid was put into the load dimple where it acted as a visco-elastic dampening fluid. The 263 kHz signal disappeared when this technique was applied (Figure 3, right).
