The Independent Fact Group

Recovery damage to the visor

STATEMENT REPORT

Subject: Recovery damage to the visor
Type: Statement
By: Johan Ridderstolpe and Björn Stenberg
Status: Proved
Date: 1 May 2000
Version: Report - English

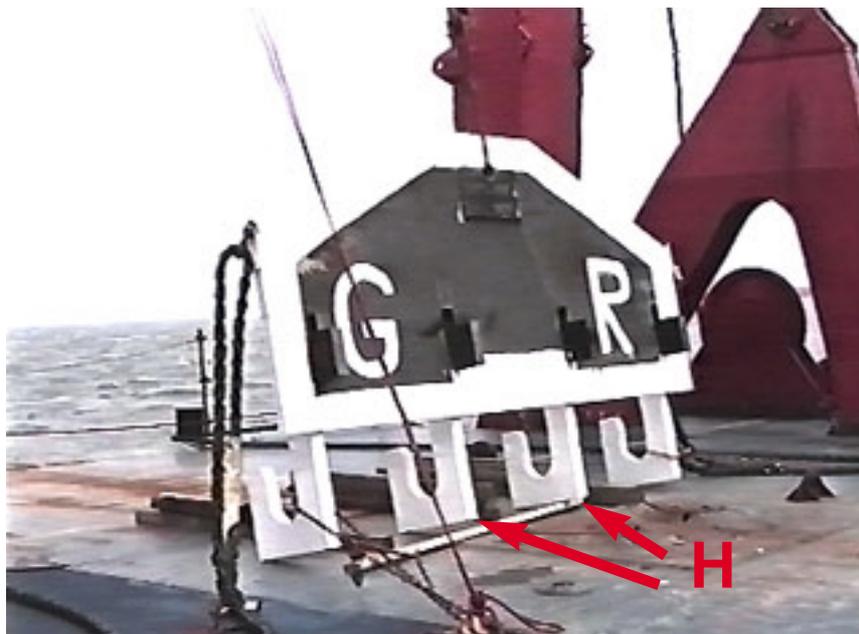
Picture 3. The picture shows the yoke hanging from the aft crane on the MSV Nordica. The four hooks can be seen hanging from the yoke (H).

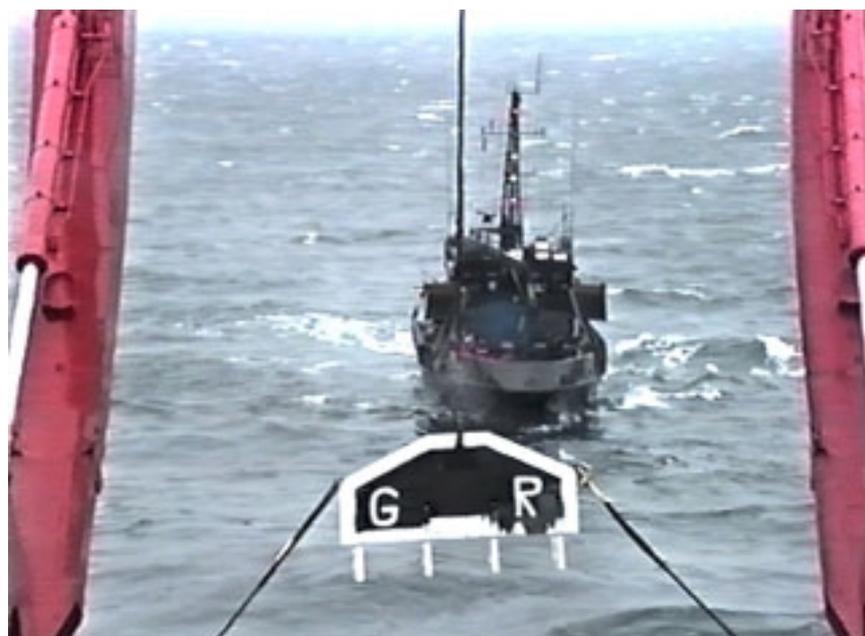
Picture 4. The picture shows the yoke hanging over the water at the first attempt to recover the visor. In the background, HMS Furusund.

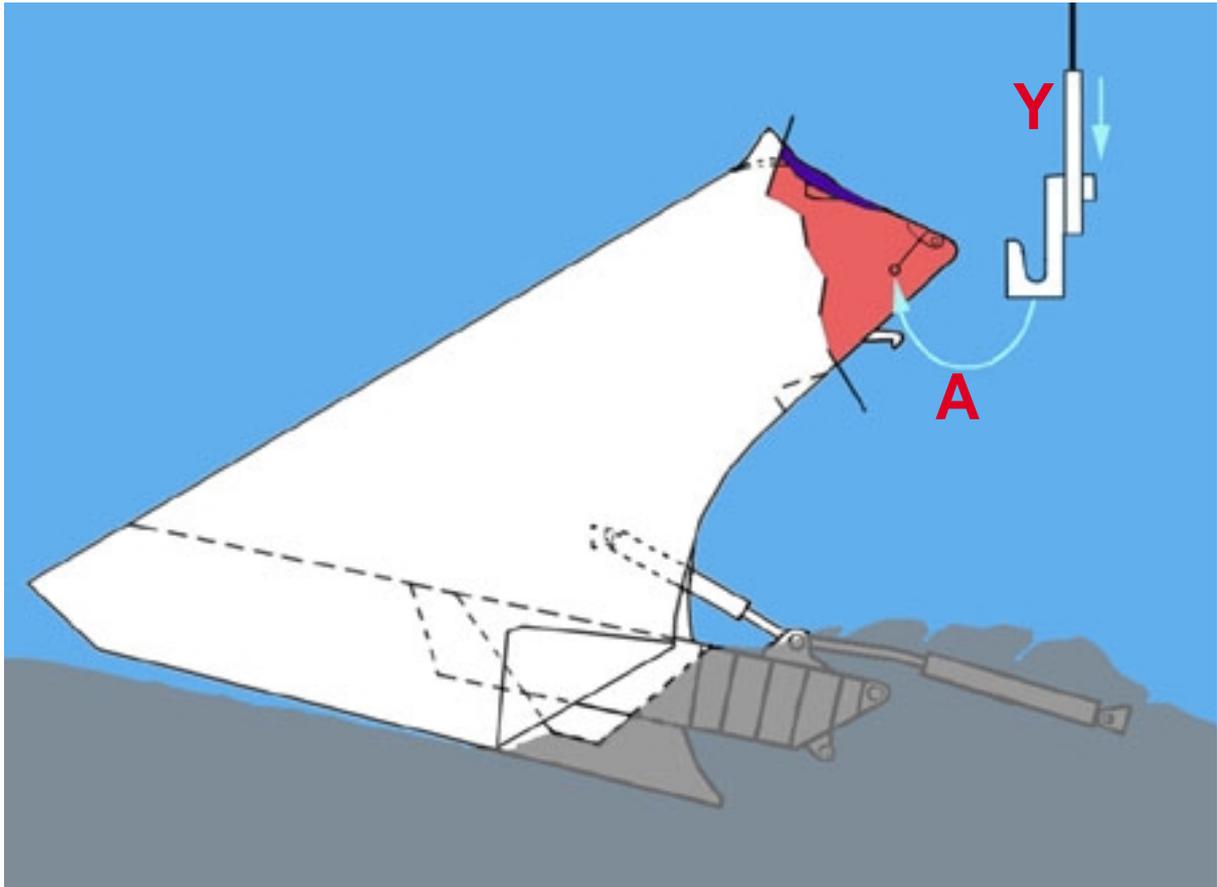
Picture 5. The yoke (Y) lowered to hook into the visor, arrow (A).

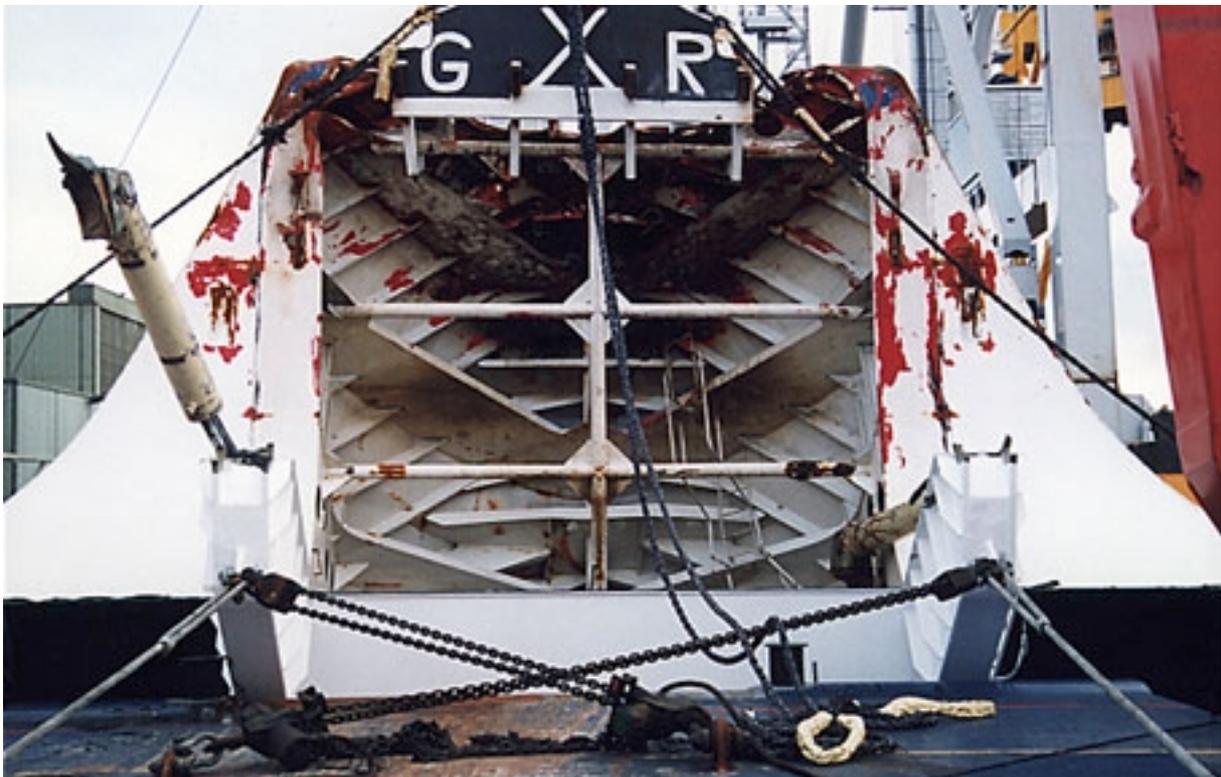
Picture 6. The yoke (marked G X R) hooked into the visor after recovery.

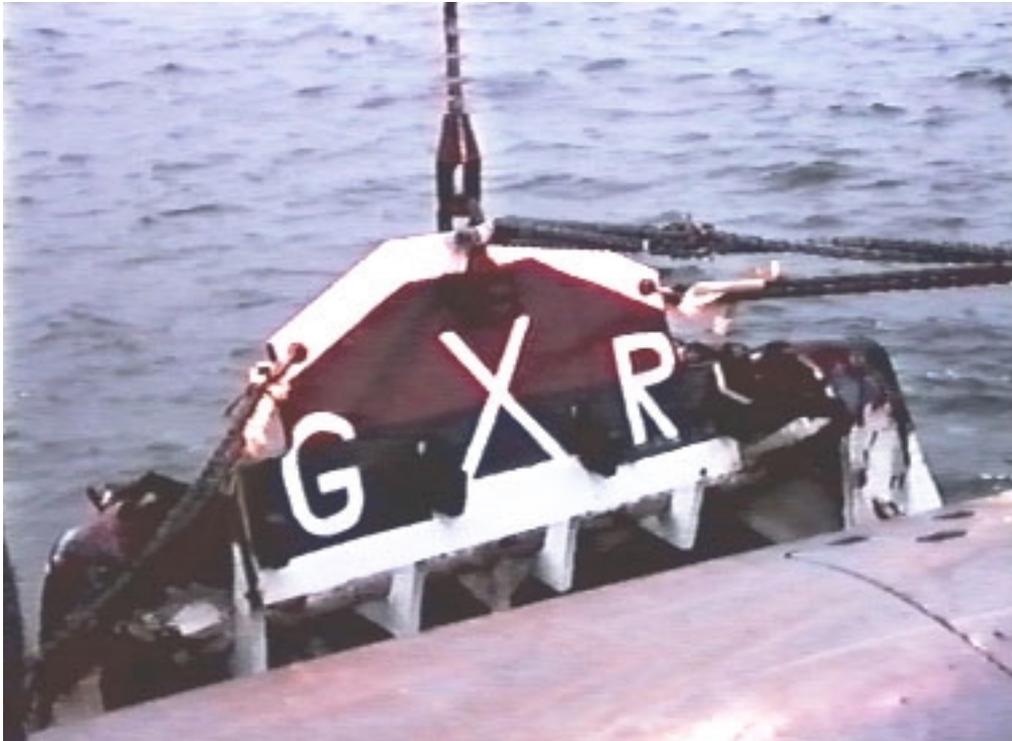
When the visor finally emerged from the water it could be seen that the yoke had become attached to the bottom construction of the visor. The four hooks were connected around the transverse tube beam close to the bottom of the visor, as seen in picture 11 and 12.

Picture 11. The visor emerging from the water.
