# Measurement of Composite Heat Damage Using the Exoscan Handheld FTIR

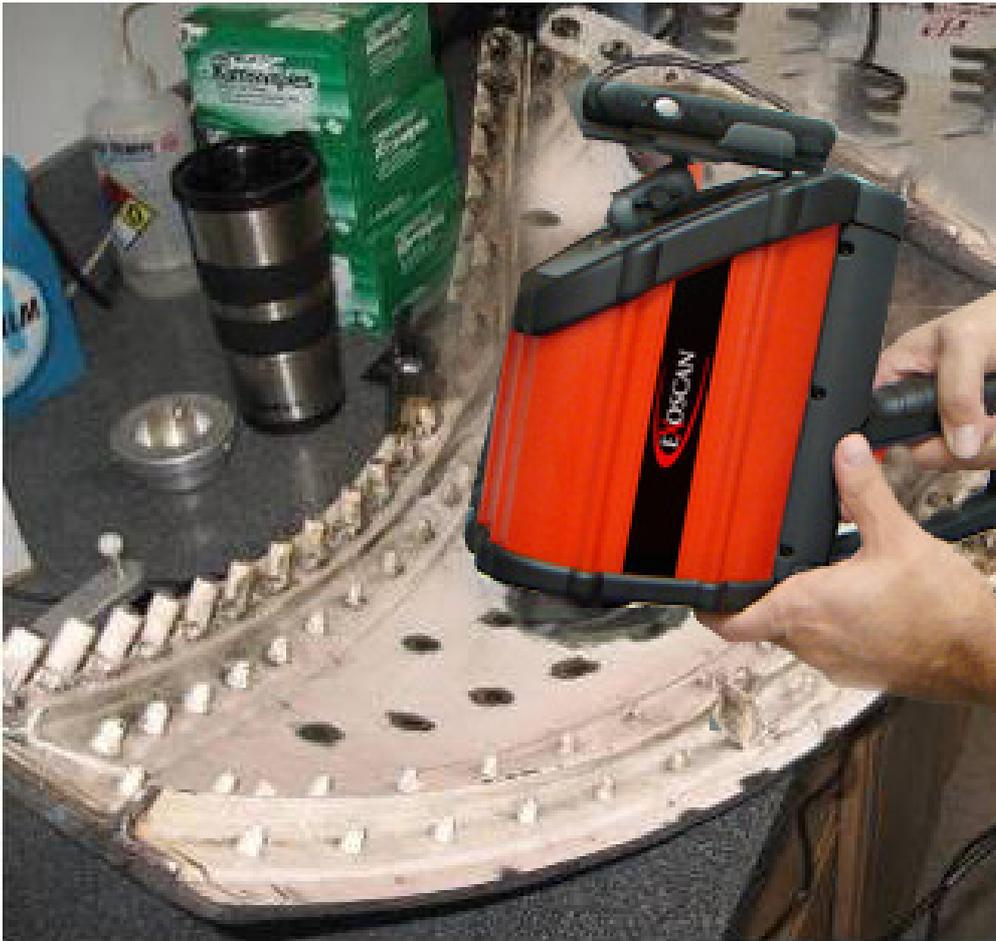
*Figure 5: An Exoscan being used to measure heat damage on a composite aircraft part which had been damaged by an engine fire.*

The Exoscan system has been used to measure aircraft parts which have been heat damaged. Figure 5 shows an Exoscan system being used to measure a part damaged in an engine fire. Due to heat transfer of the supporting structures, the damage due to the fire was not uniform across this part. In cases such as this, there is a need to measure the extent of damage at various points on the part in order to determine which areas of the composite can be repaired.

*Figure 5: An Exoscan being used to measure heat damage on a composite aircraft part which had been damaged by an engine fire.*
