TECHNICAL REPORT NO. LWL-CR-02P69

LISTENING POST SURVEILLANCE DEVICE (LPSD)  
AN/PPS-14

Final Report  
Contract No. DAAD05-69-C-0279

Aerospace Research, Inc.  
130 Lincoln Street  
Brighton, Massachusetts 02135

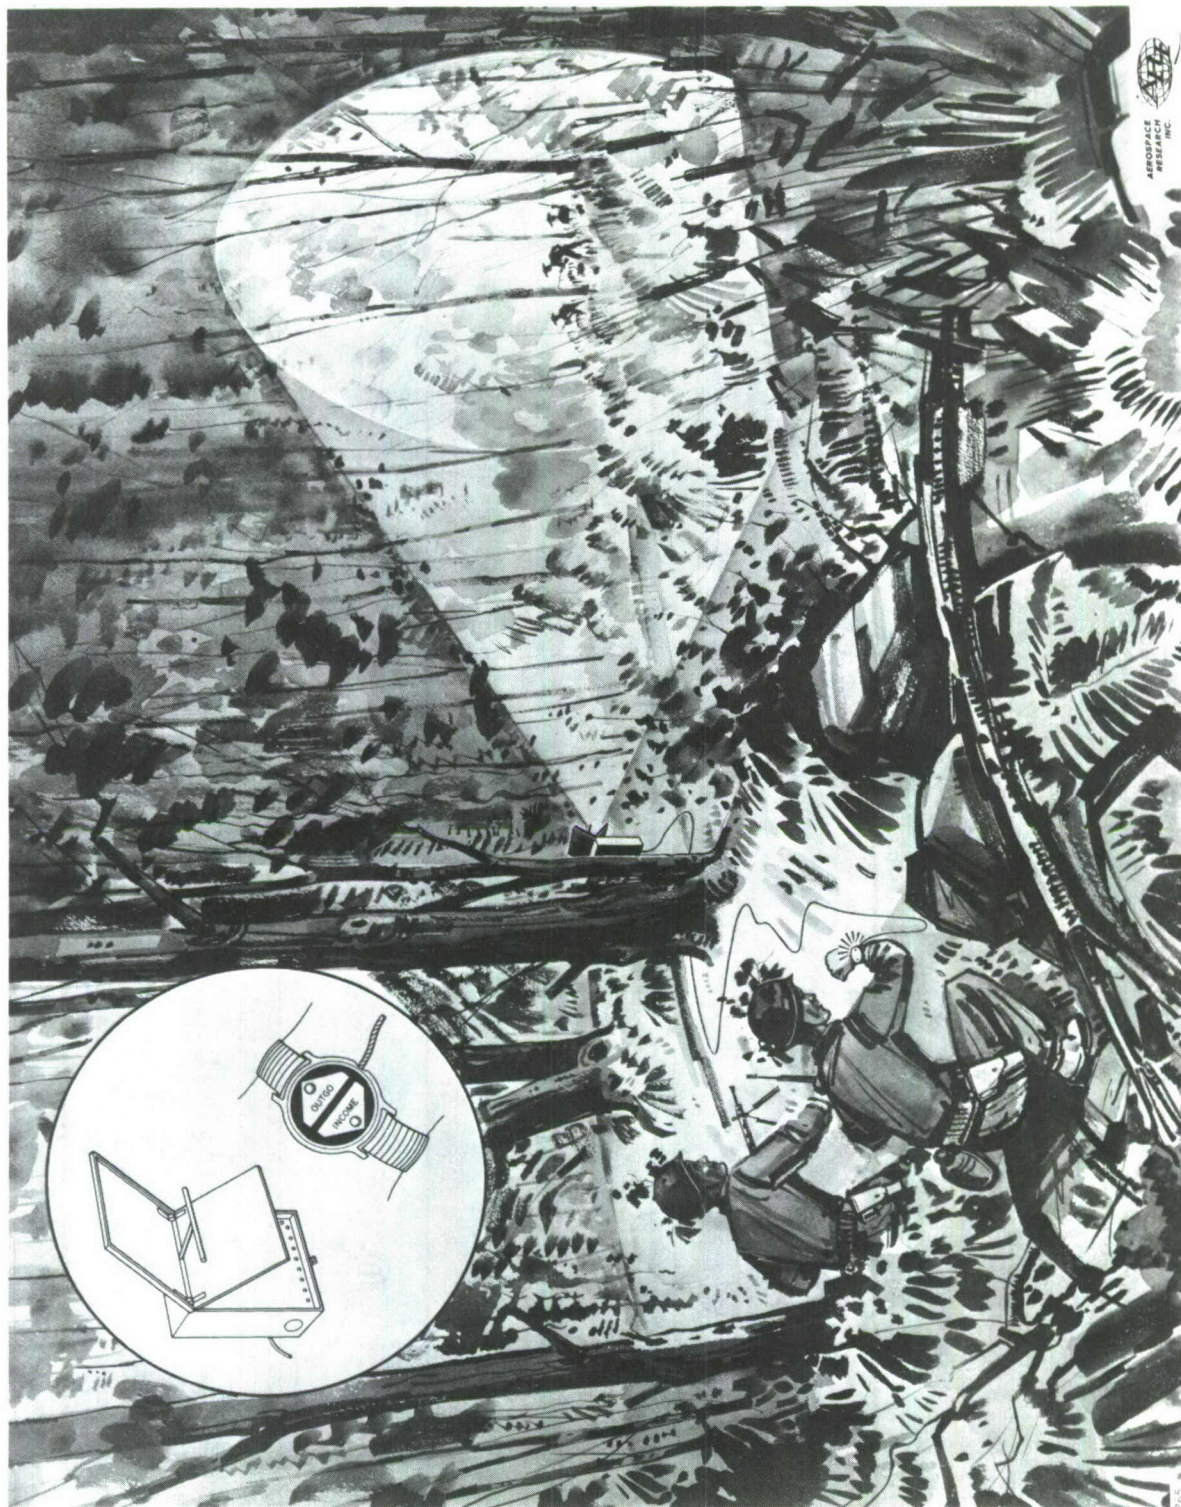
Figure 8: Artist's Conception of LPSD in Operational Use

An artists conception of the field operation of the LPSD is shown in Figure 8. The LPSD radar unit with its antenna in the operate position, and the wrist alarm is shown in the insert.

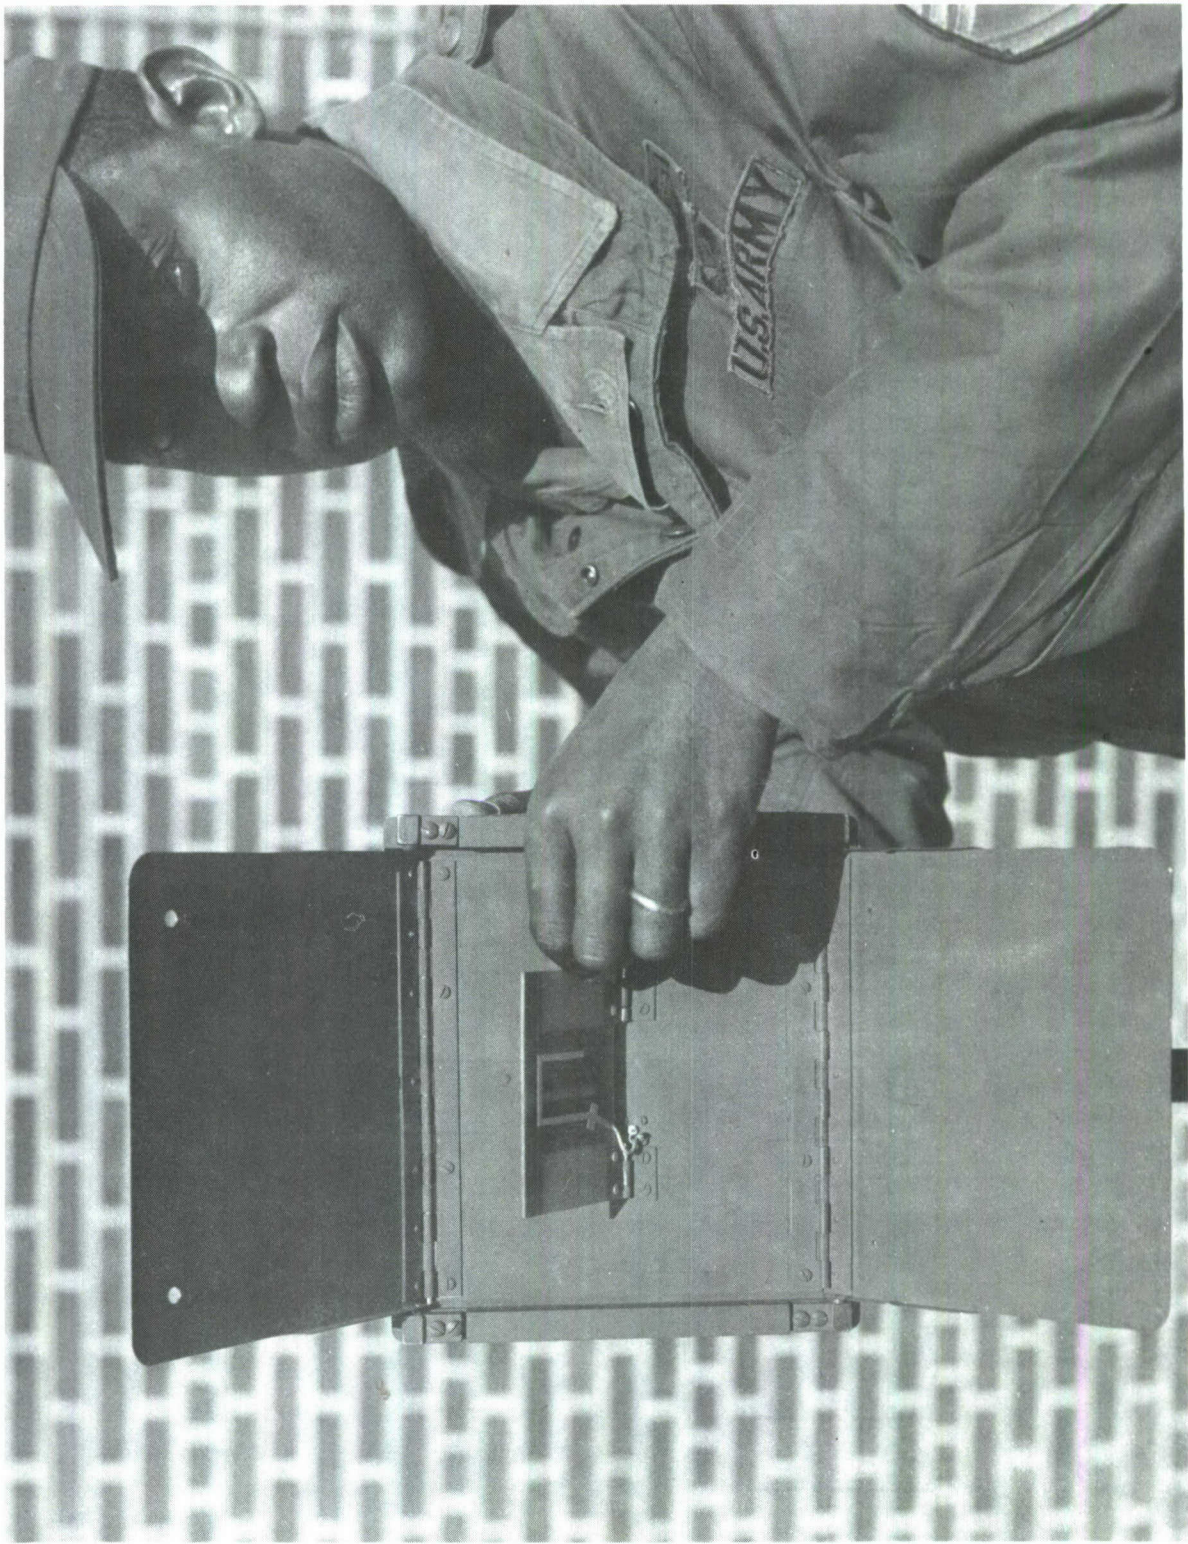
Figure 23: Radar Unit with Antenna in Operating Position

1. Power - 15 mW rms, 60 mW peak
2. Frequency - 1.25 GHz  $\pm$  5 MHz
3. Vertical beamwidth - 46<sup>o</sup> maximum
4. Horizontal beamwidth - 72<sup>o</sup> minimum
5. VSWR - 1.4 maximum
6. Front/Back ratio > 25 dB
7. Front/Side ratio > 15 dB
