# AGILENT 4100 EXOSCAN FOR ANALYSIS OF COMPOSITES USED IN BOEING AIRCRAFT

## Data Sheet

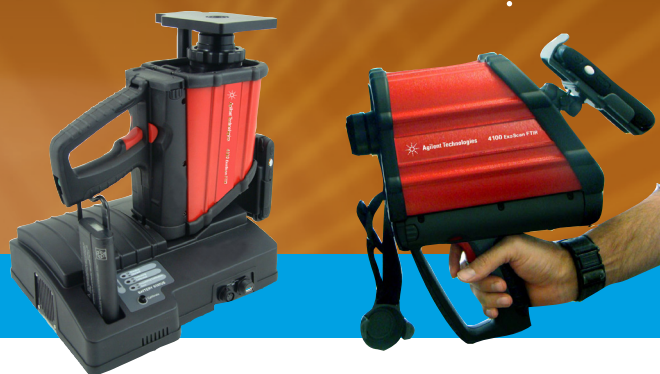
Composites have become popular materials to use in a variety of applications; this includes their usage in the Aerospace and Aviation marketplaces. The 4100 ExoScan FTIR has been shown to be an effective, non-destructive technology for measuring heat exposure in composite materials (“Composite Heat Damage measurement using the handheld Agilent 4100 ExoScan FTIR” by J. Seelenbinder).

The ExoScan system identifies changes in the chemical structure of the epoxy polymer component of the composite matrix. The ExoScan software correlates these observed changes to the extent of exposure by comparing the data to pre-developed methods. In this way, the system is used as a non-destructive analyzer to determine the depth and breadth of thermal exposure which is particularly valuable in support of the composite repair processes.
