# Application Note *VIB-D-01*

## LDV Investigation of Unstable Air Bearing Resonance Effects on Low Flying Heads

Polytec GmbH  
Laser Measurement  
Systems  
Application Note  
VIB-D-01

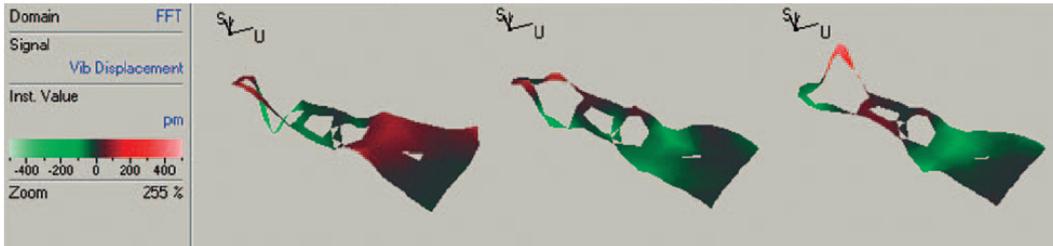
Figure 2 shows the 263 kHz signal that causes the suspension at the area of the head mount to oscillate with both bending and torsional modes. The rest of the suspension remained essentially stationary without any significant oscillation.

**Figure 2: PSV Scanning Vibrometer measurement of bending and torsional oscillation of the suspension**
